Location: Western United States

Problem

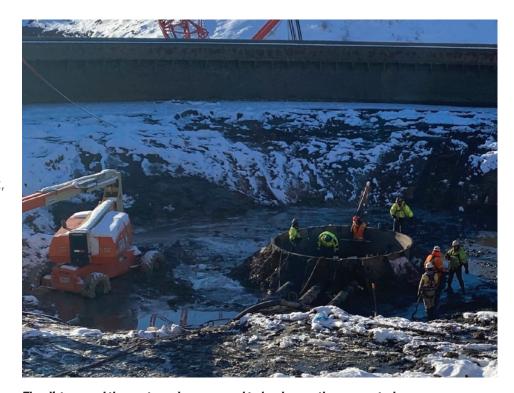
The dirt around the center column proved to be deeper than expected.

Careful planning enabled us to effectively overcome the inevitable surprises that arise with all projects. For example, the team expected to dig out 2 to 3 feet (0.6 to 0.9 meters) of fill dirt to reach the existing center column's base on the irregularly shaped thickener floor. The dirt around the column proved to be much deeper.
